**SCOPE OF WORK
FOR
FORBESTOWN DITCH TO PIPELINE
REPLACEMENT PROJECT**

**Prepared for:
North Yuba Water District
8691 La Porte Road
Brownsville, California 95919**

September 2019

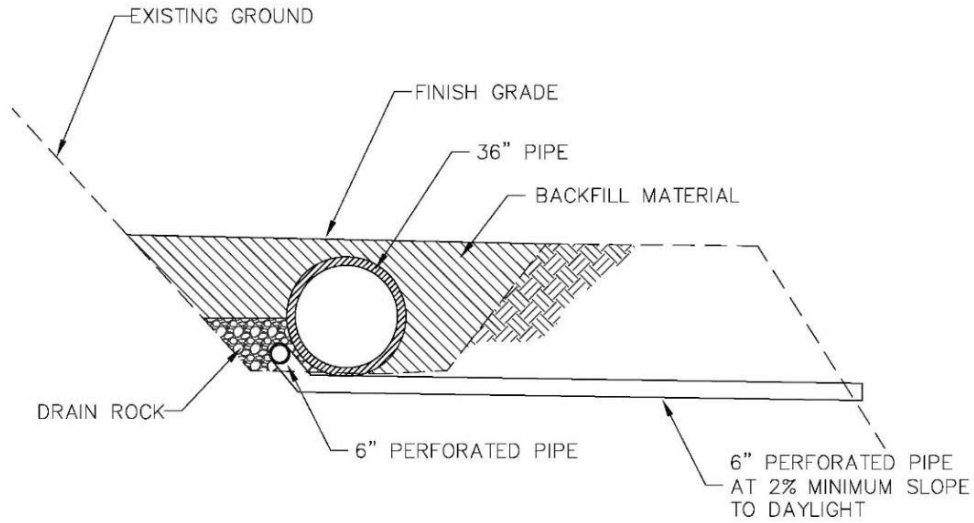
This method will have the 42-inch diameter pipe installed within the existing ditch and covered with 2 feet of backfill materials. This will create a wider access road above the pipe for future maintenance and repair of the system. It will also prevent any pipe from being damaged due to fire and/or vandalism. This method of construction, however, requires the backfill materials to be imported from offsite since there are very minimal materials available onsite.

Installation of pipe below grade still requires any water that goes in to the ditch to be drained in order to prevent any issue with hydraulic uplift pressure and soil saturation below the ditch. Perforated pipes and drain rocks can be installed parallel to the HDPE pipe to capture subsurface flow and divert it out of the channel to its natural course at the lower side of the ditch. The cost associated with providing and installing perforated pipe, drain rocks and backfill materials is approximately \$160 per linear foot. Figure 1 shows the Typical Section

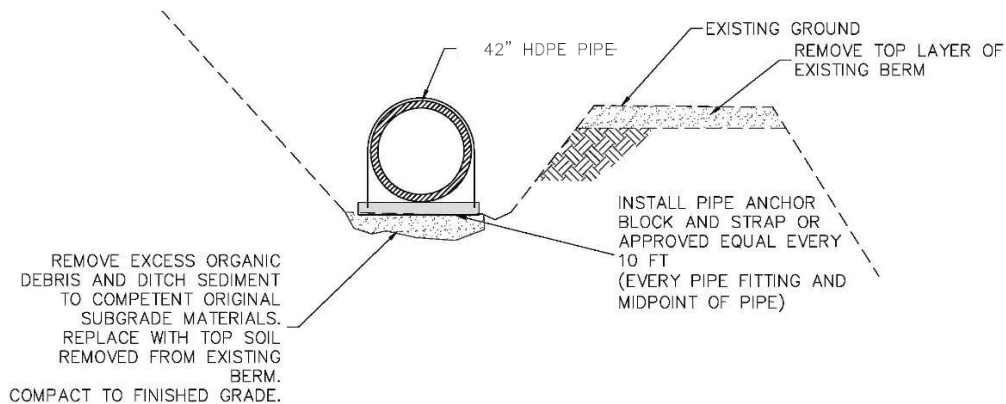
This method will have the 42-inch diameter pipe installed at grade and supported by pipe anchor blocks. It will be an advantage for future maintenance and visual inspection of the system. NYWD staff will be able to conduct routine visual inspections of the pipe to detect any maintenance requirements and repairs. Early detection of sagging and deformation of the pipe due to minor soil creep will allow mitigation prior to any major failure. This method, however, will not provide the pipe with any protection against fire damage and vandalism.

Pipe anchor blocks will have a typical dimension of 4-foot-long x 1-foot-wide x 6-inch-high with an insert on each end for pipe strap attachment and installed every 10' to provide a sufficient structural support. The installation of the blocks underneath of the pipe will also provide gap that will allow any surface flow across the pipe without additional excavation. The cost associated with providing and installing the pipe anchor block is approximately \$30 per linear foot. Figure 2 shows the Typical Section.

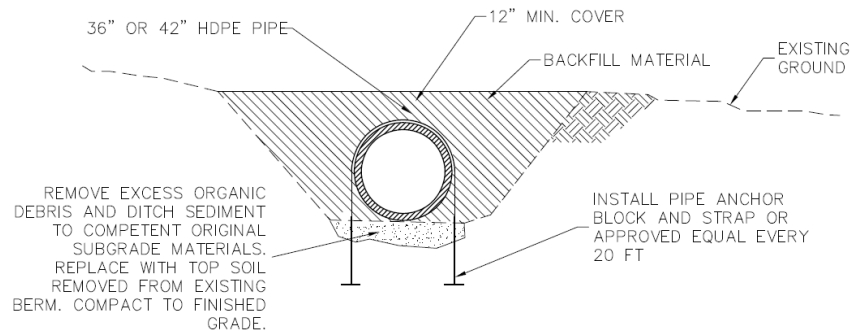
This method will have the 36-inch and 42-inch diameter pipe installed within the existing ditch and covered with a minimum 1 foot of backfill materials. The system will be anchored to the ground using pipeline anchoring system installed at every 20 ft preventing the pipe from floating caused by hydrostatic uplift pressure. This method is feasible for the lower section to prevent the pipe from being vandalized since it is near the residential areas. It will also prevent any unpermitted pumps from being installed to divert water out of the system.

The pipeline anchors will be designed and sized to handle the loads caused by the uplift pressure eliminating the need for subdrain.

Unlike the upper section of the pipe system, this portion of the project is not expected to experience the un-equal horizontal hydrostatic loading of the pipe that causes the low side berm failure and pipe blow out. This portion of the project is also easily accessible by the heavy equipment which make constructability a non-issue. Figure 3 shows the Typical Section.

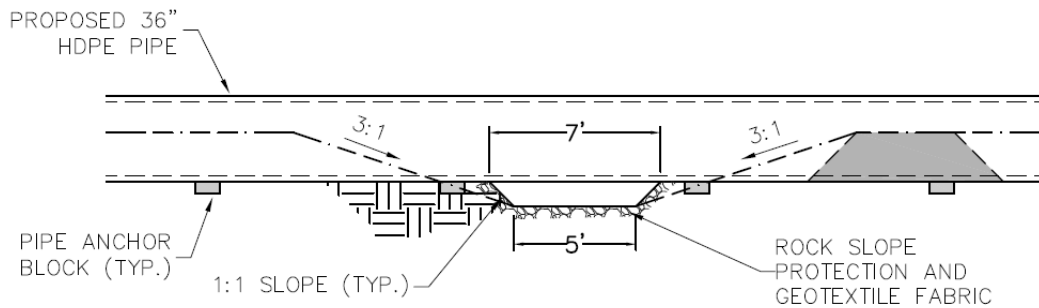
Figure 4

Historically, there are several surface runoff areas that drain to the existing channel. The surface water from these areas are assumed to introduce bacterial contamination and will not be captured in the conveyance system once the pipes are installed. The surface and subsurface water will continue to flow into the ditch but will be conveyed and released to its natural drainage course by constructing an open conveyance along the access berm allowing the flow to pass under the pipeline without the use of a culvert. The conveyance will have a dimension of 5-foot-wide (bottom) by 1 foot deep with a side slope of 1:1 below the pipe and lined with rock slope protection and geotextile fabric to prevent erosion. An engineered dip will be constructed along the access berm to allow conveyance crossing and still maintain access. The dip will have a 5-foot-wide (bottom) and 3:1 side-slope for an accessible transition. Construction of the conveyance will

prevent the water from ponding in the ditch that causes hydrostatic uplift pressure and soil saturation. Figure 7 shows the Typical Section.

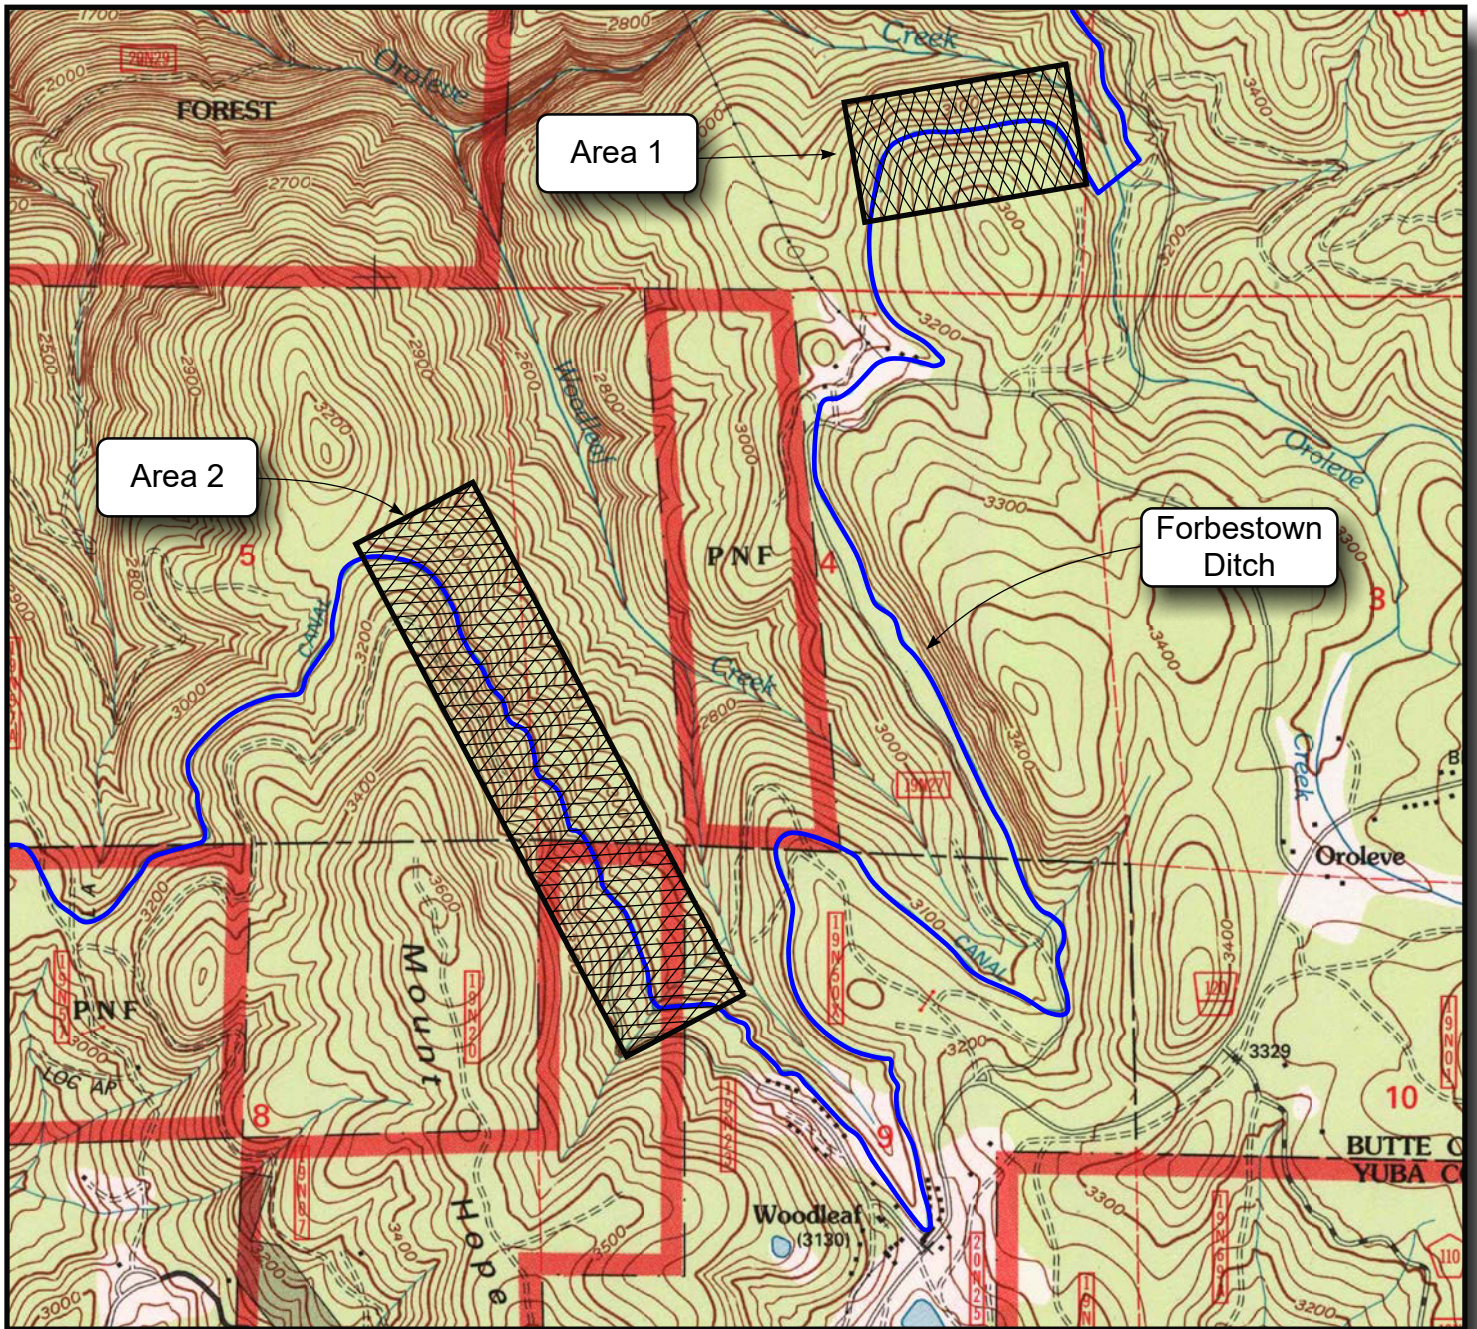
AREAS OF CONCERN

As noted above, two areas of slope stability concern were identified to VSI as part of this study. Those locations are noted on Plate 2 and described as follows:

At the Emergency Repair Site 2, located between about Stations 295+80 and 298+20 (Northstar, 2017), a relatively deep-seated rotational/translational landslide damaged the ditch, necessitating emergency repairs. At this site, tension cracks, scarps, and other geomorphic indicators of slope instability were observed in areas where grading had not removed those features. In addition, groundwater was being discharged from the slope at a number of locations and we understand that subsurface improvements were installed during the repair to capture and divert groundwater.

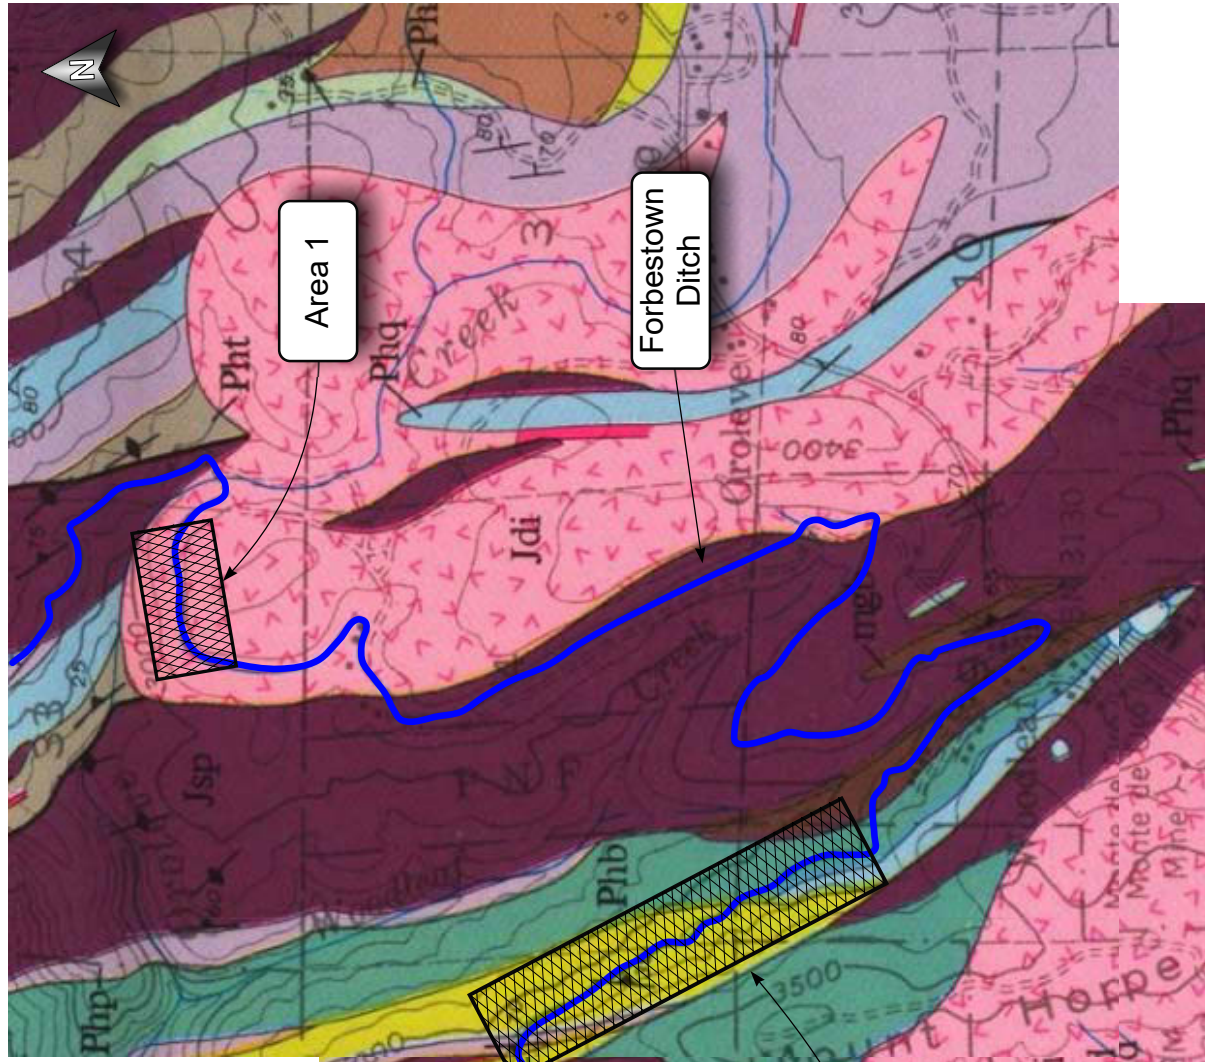
MAPPED GEOLOGICAL CONDITIONS

Geologic maps of the study area have this section of the ditch mapped extending across undifferentiated diorite and quartz diorite rock materials (Heitanan, 1976), as shown on Plate 3 – Mapped Geological Conditions. Soil survey maps for the area identify the Mariposa Gravelly Loam and underlying the area (NRCS, 2017).

- Metabasalt – Dark-gray to black foliated hornblende-albite rock with some epidote and magnetite
- Meta-andesite – Greenish-gray fine-grained massive to foliated epidote-actinolite-hornblende-albite rock with or without chlorite

- Metadacite – Light-greenish-gray massive to foliated albite-quartz-actinolite-hornblende-epidote rock with or without chlorite
- Metarhyolite – White- to light-gray massive to foliated quartz-albite-biotite-muscovite-epidote rock with some actinolite. Some occurrences are rich in potassium feldspar, some others in biotite
